Form Name: **SST Best Practice Submission**

Site Decommissioning

Initial Incident Description:

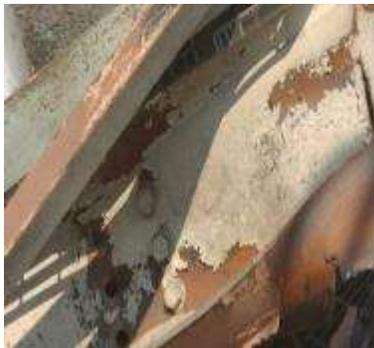
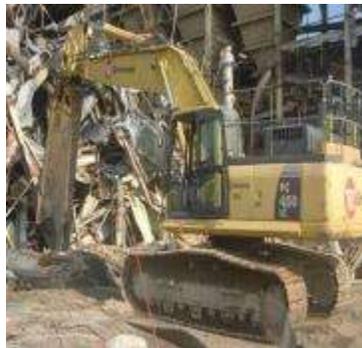
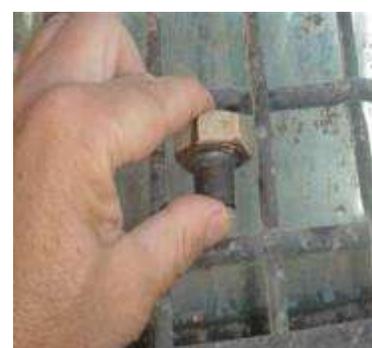
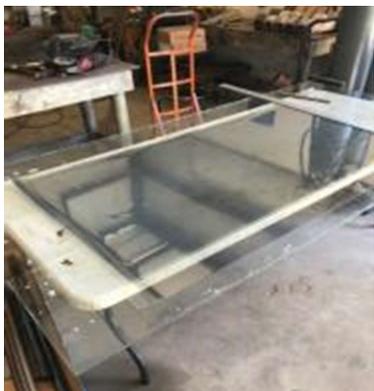
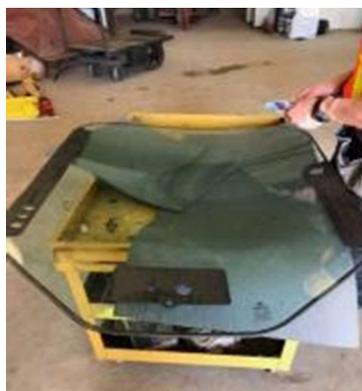
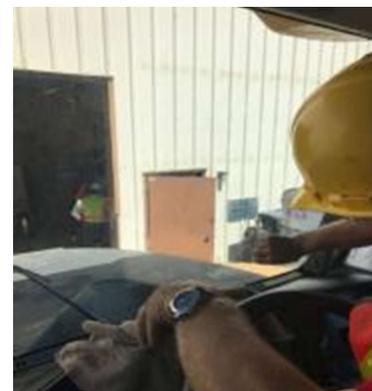
A Komatsu 450 excavator, configured for demolition activities, was shearing an 8 inch structural steel beam from previously demolished structure. The operator was using the shear approximately 12 to 18 inches from a 6 bolt splice plate. As the hydraulic shear head began cutting the beam, 3 bolts in splice connection failed and traveled approximately 8 feet with considerable force.

Metal demo screens are used on all demo equipment however; an inherent weakness is size of screen versus operator visibility that still affords sufficient protection. One bolt head was small enough to penetrate through the metal demo screen (2" x 2") shattering the window and striking the operator in the abdomen. Fortunately, the operator suffered no injury from the bolt or shattered glass fragments.

While the process of shearing next to splice plates was changed to help mitigate this hazard, a more proactive solution following the hierarchy of controls was required. After consideration an engineering control was proposed and contractor ultimately installed security film laminate on all demo equipment front windshields. This included excavator with shear or grapple attachments, front end loaders, off road haul trucks, and skid steers. The use of the laminate is same type used for police stations, and store fronts to eliminate and or mitigate flying glass and projectiles due to explosions, weather events, and vandalism. It adds additional protections to operator and significantly reduces the velocity of projectiles. Most buildings or offices to meet FEMA standards typically use a laminate of 7mm, the contractor elected to use 8mm laminate on all the interior windows. Manufacturer # SCL SR PS8.

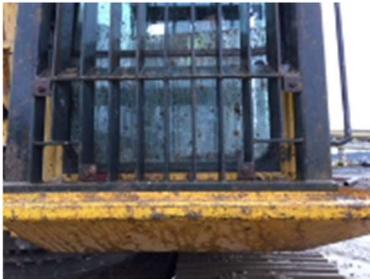
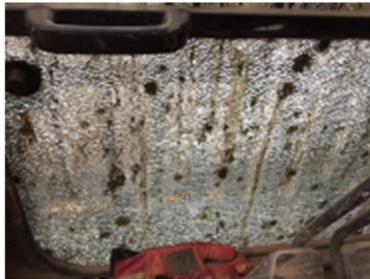
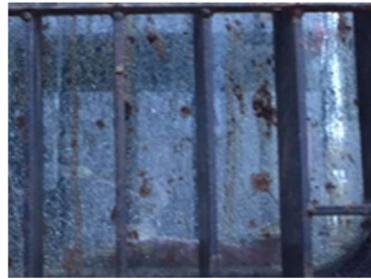
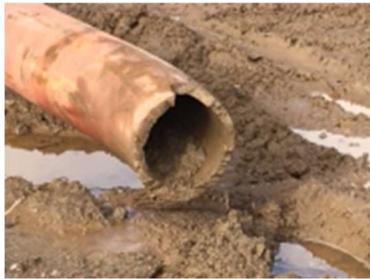
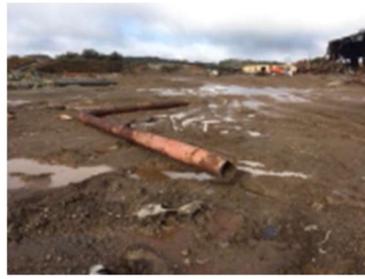
Incident 2: Employee was operating a Komatsu PC 400 excavator with a bucket and thumb attachment (grapple). The operator was pulling debris from the drop zone of the coal hopper implosion area. The equipment was moving a 60' length of carbon steel pipe 12" in diameter and 2' thickness. The pipe slipped from the bucket and thumb dropping to the ground; where a rock was displaced becoming airborne. The rock went through the larger demo screen and struck the windshield. The rock projectile did not penetrate the window; the glass was shattered, but remained intact, held in place by the installed laminate. There was no injury to the operator. The windshield is scheduled to be replaced and the laminate re-installed.
