# SAFETY ALERT

## Summary

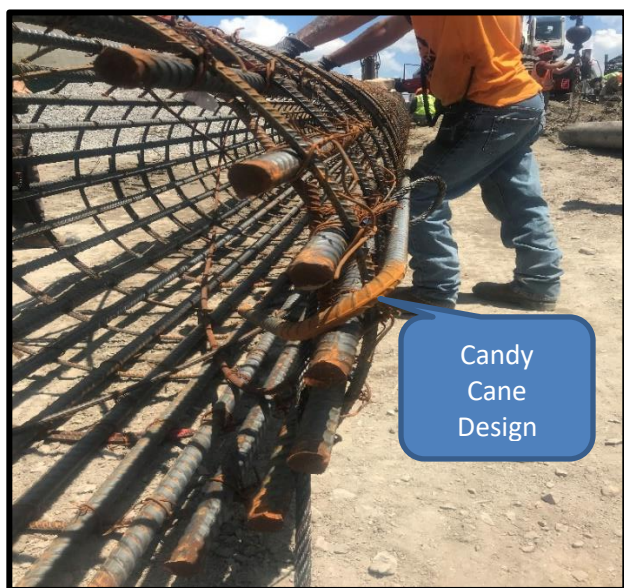
New candy cane design

- Enhanced procedure for rebar cage installation.
- Use a candy cane-shaped lifting bar to ensure desired position.
- Tie lift bars at each intersection point along the 8-ft length of the bar 100% using double tie wire in a figure-eight.
- Use # 9 wire on all horizontal rebar from the lift point and above.
- A two-person verification system was implemented to review all pre-lift documents and rigging prior to lift.

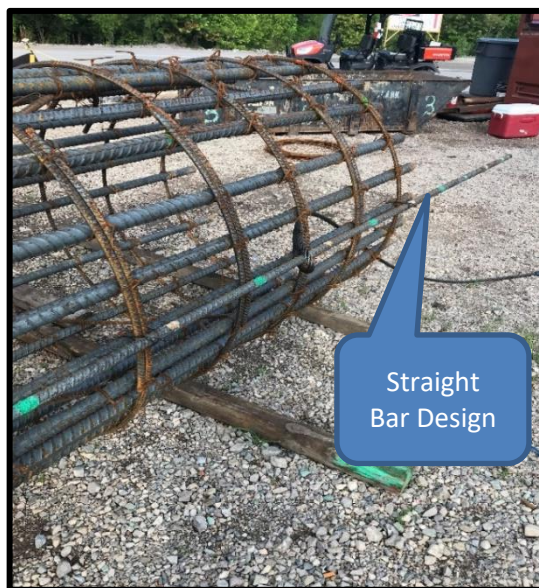
Old design

- Deficiency in lifting procedure
- Incorrect tool for task

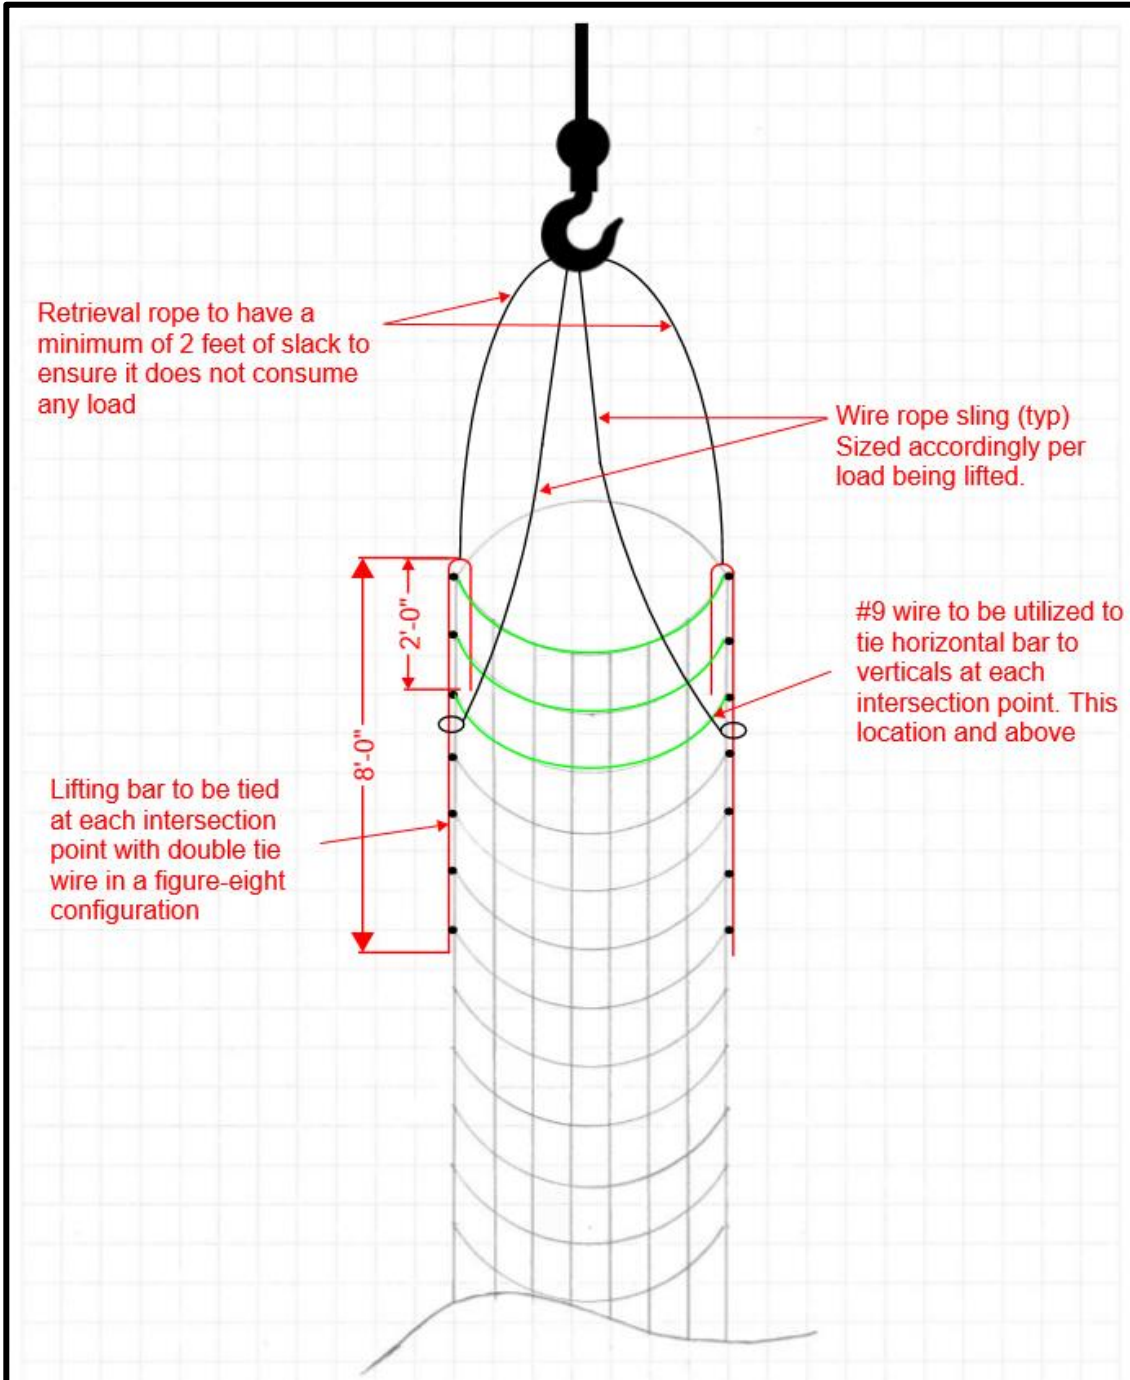
Diagram of new candy cane design
