What You Should Know:

Contractors tasked with core drilling two access holes in the concrete floor in a Southern Company Hydro facility control room used ground penetrating radar (GPR) (Figure 1) to inspect the floor where the holes were to be drilled to ensure no objects were embedded in the concrete. However, despite an absence of visible indications of obstructions on the scan in both cases, each core drill bit contacted an energized 110-V circuit embedded in the concrete floor. Fortunately, no one was injured by the electrical contact with the core drilling machine, but a Stop Work was enacted until the event could be better understood.

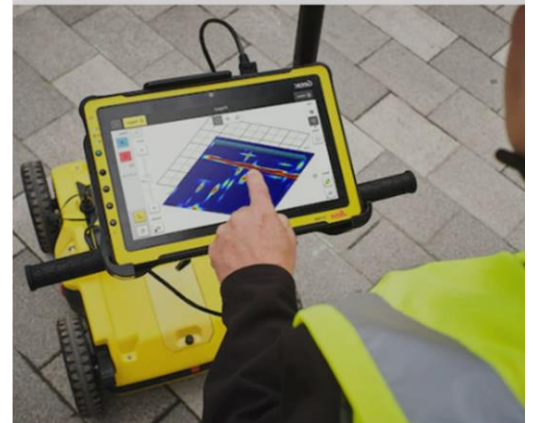
Figure 1. Typical Ground Penetrating Radar device

GPR is a good tool for looking into concrete slabs, and is reliable in identifying structural components, post-tension cabling, and larger conduit at depths up to 28 in. The radar waves return signals to a transponder to provide the location of any object that has a greater or lesser reflectivity than the surrounding concrete. However, the composite nature of concrete coupled with the small diameter of the 110-V conduit reduced the tool's ability to differentiate the conduit from the surrounding material. As a rule, GPR can best detect objects with a diameter of 1-in. for every 1-ft. of embedment depth, which displays a resolution of approximately 5-cm or 2-in. wide, although the resolution of the GPR scan is primarily determined by the wavelength of the radar waves being used.
